## Engineering Geological Issues after Gorkha Earthquake 2015 in Nepal - a preliminary understanding

### Abstract

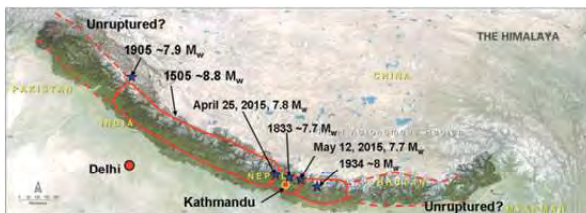
Fig. 1 Major earthquakes in the Himalayan region, modified after Zurick et al.(2005) and USGS (2015)

The southern part of the Himalaya, i.e. Ganges Delta of northern India has extremely high population density is in an area very close to historic great earthquakes, demonstrated high strain accumulation (Fig. 1).

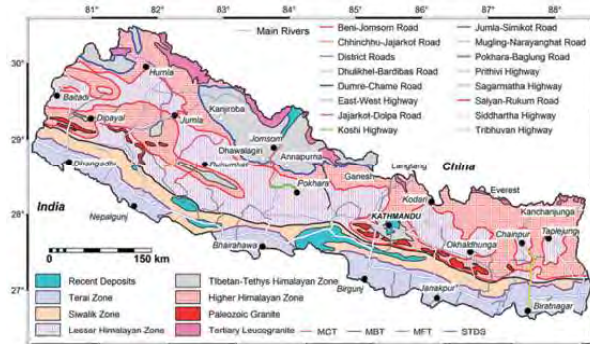
Fig. 2 Geological map of Nepal with major road networks (modified after Dahal and Hasegawa (2008)

Geologically and tectonically, Nepal is divided into five major tectonic zones, namely, Terai Zone, Siwalik Zone, Lesser Himalayan Zone, Higher Himalayan Zone and Tibetan-Tethys Himalayan Zone (Ganser, 1964). These tectonic zones are separated by major thrusts and faults of the Himalaya and those faults and thrusts are named from north to south (Fig.

2) as South Tibetan Detachment System (STDS), Main Central Thrust (MCT), Main Boundary Thrust (MBT) and Main Frontal Thrust (MFT). Likewise, geomorphologically, Nepal is divided into eight units running east-west, namely, Terai, Churia Range, Dun Valley, Mahabharat Range, Midland, Fore Himalaya, Higher Himalaya, Inner and Trans Himalaya (Dahal and Hasegawa, 2008).

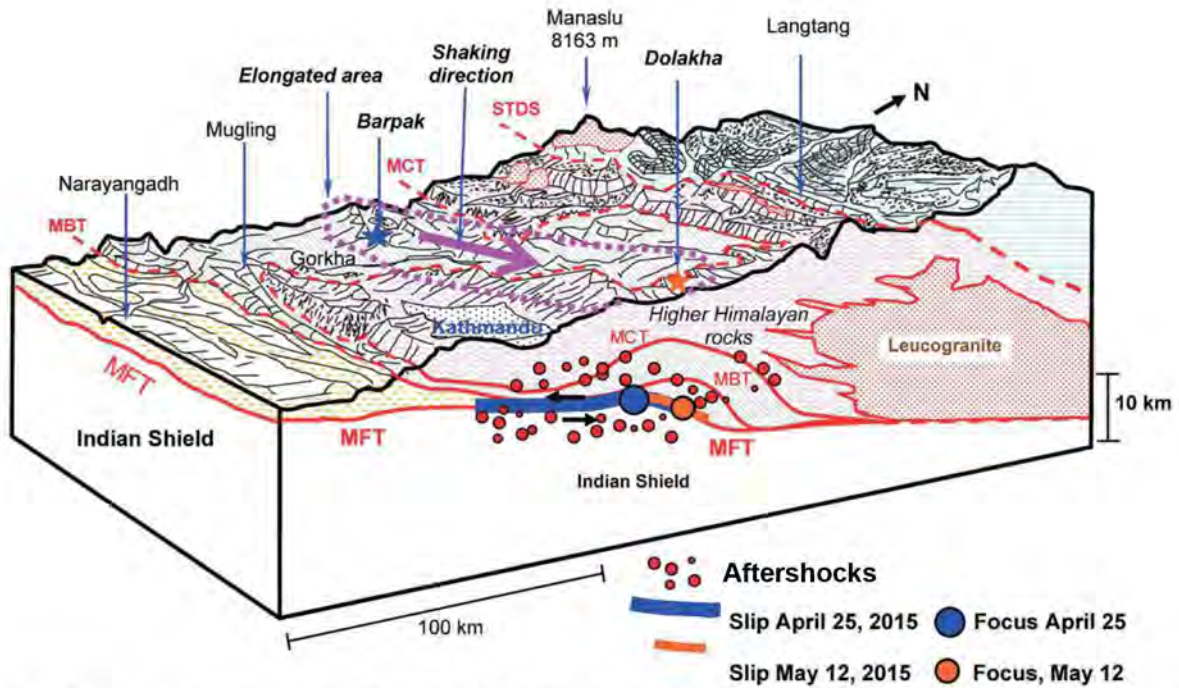
Fig. 3 Block diagram of area affected by 2015 Gorkha Earthquake, Generalized cross section showing the approximate locations of slip during the 25 April and 12 May 2015 ruptures on the Main Frontal Thrust (MFT). Locations of both Barpak and Dolakha epicenters as well as aftershocks are schematic only and all are projected on vertical plane of sight. The elongated area faced strong-severe damages/shaking and it is extended towards east up to Dolakha. The block model is modified after (Hasegawa et al. 2009).

Generalized cross section is shown in Fig. 3 and it illustrates the approximate locations of slip during the 25 April and 12 May 2015 ruptures on the Main Himalayan Thrust, and approximate aftershock locations of both events.

As mentioned in earlier section, 7.8  $M_w$  was main shock on 04-25 at 77 km NW of Kathmandu. More than ~100 subsequent aftershocks were occurred eastward of main shock. M 7.3  $M_w$  aftershock hit on 05-12 at 80 km NE of Kathmandu. Most earthquakes are shallow angle thrust faulting on decollement of Main Frontal Thrust (see Fig. 3). Main shock slip was directed towards east from hypocenter with peak slip about 4 m (USGS, 2015). The block dimensions is approximately 120 x 80 km. Shaking estimates in epicenter region are poorly constrained due to fewer intensity observations and absence of strong ground motion data. Likewise, predominantly strong to very strong shaking were focused around aftershock hypocenter and severe shaking was elongated eastward from Barpak (epicenter of April 25, 2015) to Dolakha (May 12, 2015) as shown in Fig. 3.

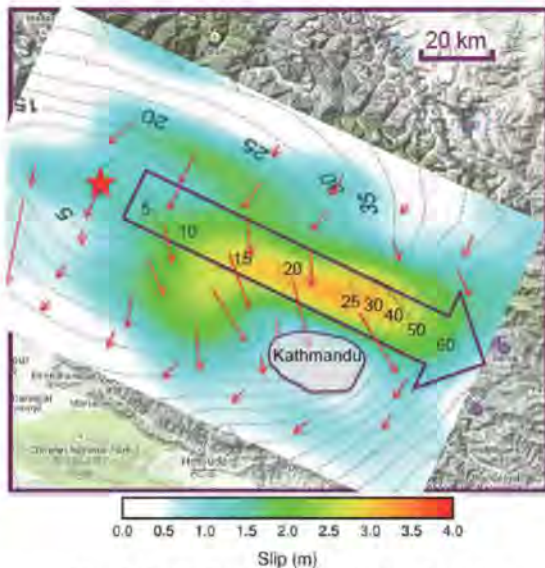
Fig. 4 Fault displacement during Gorkha Earthquake (IRIS, 2015)

Contours show the rupture front in 5 second increments after rupture initiation. Small red arrows show the direction and amount of motion of the rocks above the fault with respect to the rocks below the fault. The amount of slip is shown by color of shading. Maximum fault displacement of about 3 meters occurred in the rupture zone in 20 km north of Kathmandu (IRIS, 2015).

The aftershock distribution outlines the rupture zone of the main shock. The rupture during the main shock initiated beneath the epicenter and propagated toward the southeast. Fig. 4 shows fault displacement during the Gorkha Earthquake. The star is the epicenter while the thick arrow shows the direction of rupture propagation towards the south east direction.

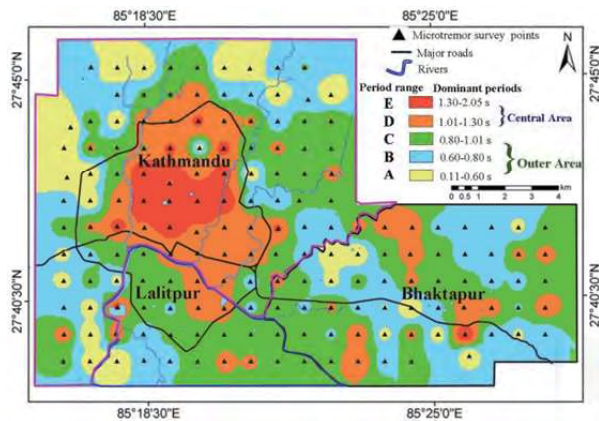
Fig. 5 Dominant natural period of ground of Kathmandu from microtremor analysis (after Poudyal et al. 2012)

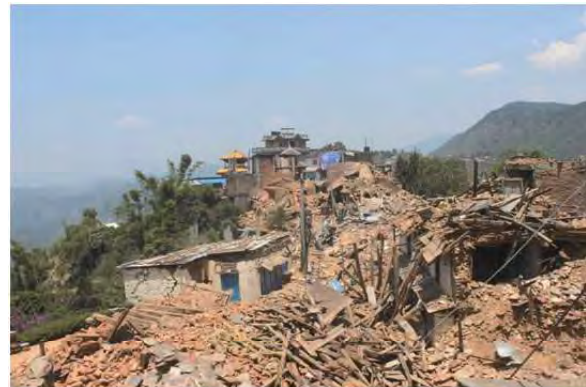
Photo. 1 Old Chautara town on ridge and damaged houses

Geli et al. (1988) have reported that buildings on crests suffer more damage than those located at the base and they conclude that there is always significant amplification of frequencies corresponding to wavelengths about equal to mountain width at hilltops with respect to the base. In the case of the Gorkha Earthquake, it is quite well observed in Chautara town in Sidhupalchowk District. Many houses on the ridges were damaged and many cracks were observed on ridge (Photo 1). Similarly, an amplification-deamplification pattern on slopes leads to a strong energy differential on the upper part of the slope. For the preliminary site visit of the Gorkha Earthquake, it is understood that landslide frequency is much higher on or near the crests of hills and mountains.

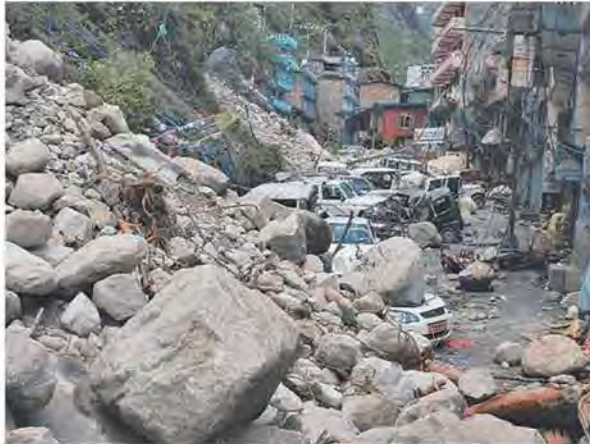
Rock fall were very common along the road side slope after the Gorkha Earthquake. Especially, Liping

Bazaar area, near to the Nepal-China border faced tremendous damages due to rock fall and boulder falls (Photo 2). Shallow landslides were common problems in the mountains at northern part of Kathmandu valley. The damages were mainly concentrated on Dhading, Nuwakot, Rasuwa and Sindhupalchowk, Dolakha districts.

Photo. 2 Rock fall in Liping Bazar, near to Nepal-China border (Photo: Kantipur)

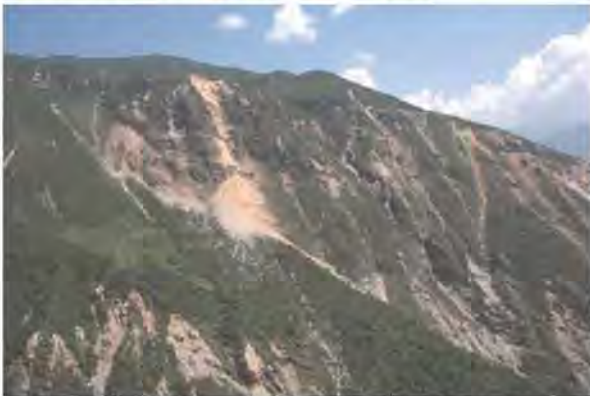
Photo. 3 Shallow failures in Sindhupalchowk district

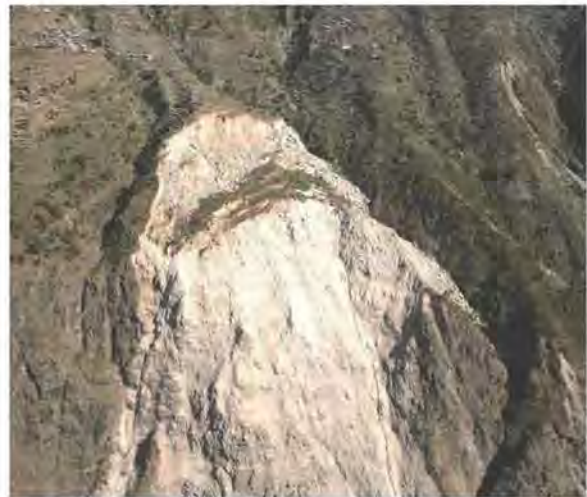
Deep-seated landslide is was not much after the Gorkha Earthquake, but few failures are seen in old landslide mass (Photo 4) in the Rasuwa district, north of Kathmandu.

Photo. 4 Failure in deep-seated old landslide

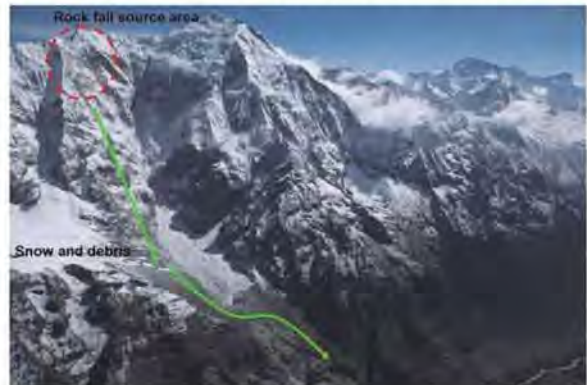
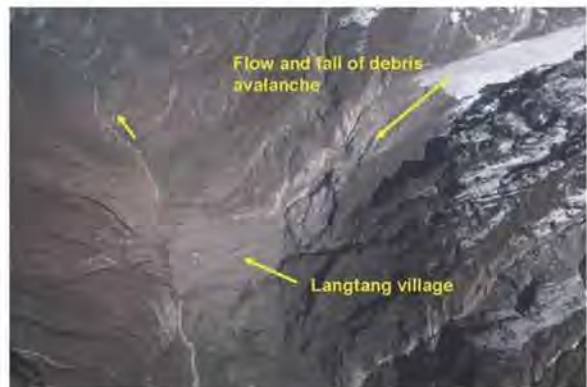
Debris flow and mud flow type of earthquake-induced landslide was not observed in the affected area due to dry season in the area, but rock fall triggered debris flow and avalanche was observed in the Langtang valley and killed more than 200 persons on the spot. The Langtang valley was vanished after this incident (Photo. 5).

Photo. 5 Debris flow and avalanche in Langtang village, source area also is shown in photo.

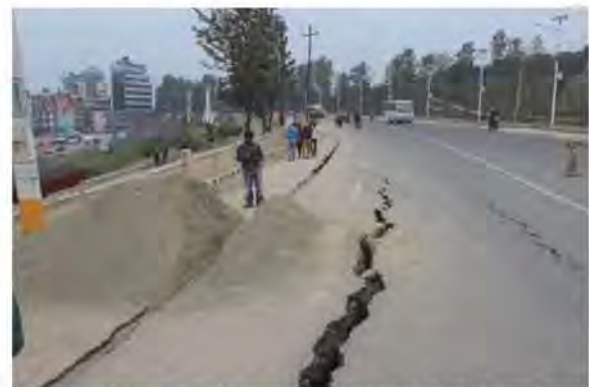
Valley fill collapse was observed in many areas, especially on road. But in Kathmandu such failures were observed only on Kathmandu airport road and the road was damaged due to valley collapse (Photo. 6).

Photo. 6 Valley fill collapse in the Kathmandu airport road.

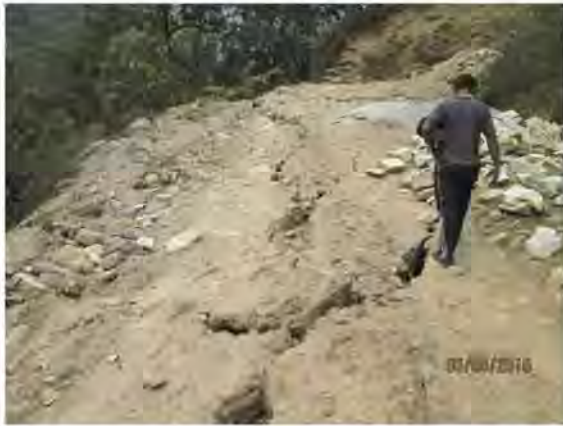
Photo. 7 Failure in Cut-and-fill part of rural road (Photo: Prem Khatri)

Cut-and-fill failures were very common in mountain roads in the affected area. Cut-and-fill land were also damaged in settlement area of Kathmandu (Photo 7).

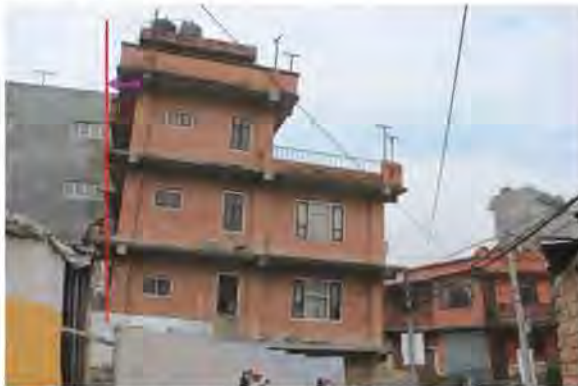
The Gorkha Earthquake was destructive not only due to structural weakness of the construction but there were many problem of differential settlement of the ground. Field visit during rapid damage assessment in Kathmandu valley suggested that nearly 40% of damages were due to land subsidence. Similarly, land subsidence due to liquefaction of lower sandy strata was also another problems observed in various location of the Kathmandu valley (Photo. 8).

Photo. 8 Land subsidence and tilting of house due to liquefaction of lower strata

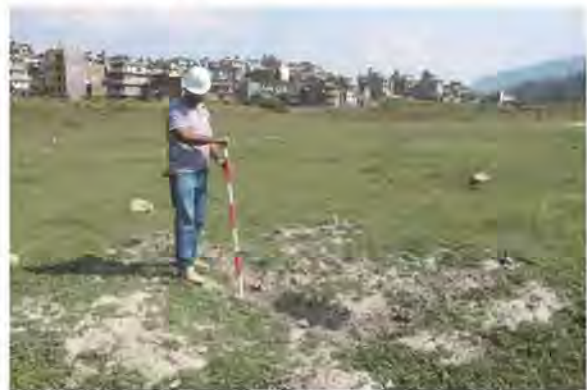
Along with land subsidence, a few sand boils were appeared in Kathmandu due to liquefaction of the lower strata (Photo 9). Although houses were not submerged inside the liquefied layer, but tilting and road collapse were appeared in many area of Kathmandu. Sand boils were appeared in southern part of the valley, mainly on the old river channel. The percentage of sand is very high in the sample taken from sand boil area (Fig. 6) shown in Photo 9.

Photo. 9 Sand boiling site at southern Kathmandu

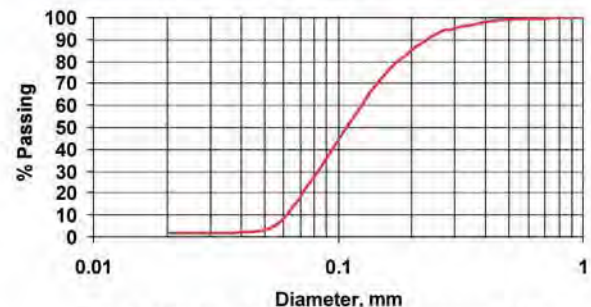
Fig 6 Grain size distribution curve of soil sample from sand boil
