Engineering Geological Issues after Gorkha Earthquake 2015 in Nepal - a preliminary understanding

Ranjan Kumar Dahal

Himalayan Geodisaster Research Center, Central Department of Geology, Tribhuvan University, Kirtipur,
Kathmandu, Nepal

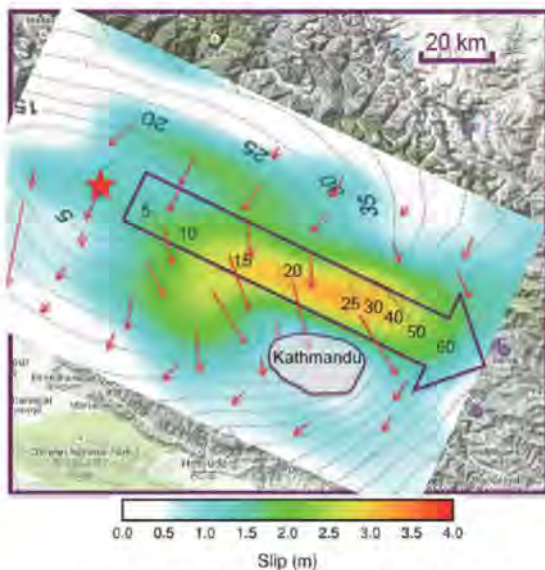
Fig. 4 Fault displacement during Gorkha Earthquake (IRIS, 2015)

Contours show the rupture front in 5 second increments after rupture initiation. Small red arrows show the direction and amount of motion of the rocks above the fault with respect to the rocks below the fault. The amount of slip is shown by color of shading. Maximum fault displacement of about 3 meters occurred in the rupture zone in 20 km north of Kathmandu (IRIS, 2015).

The aftershock distribution outlines the rupture zone of the main shock. The rupture during the main shock initiated beneath the epicenter and propagated toward the southeast. Fig. 4 shows fault displacement during the Gorkha Earthquake. The star is the epicenter while the thick arrow shows the direction of rupture propagation towards the south east direction.

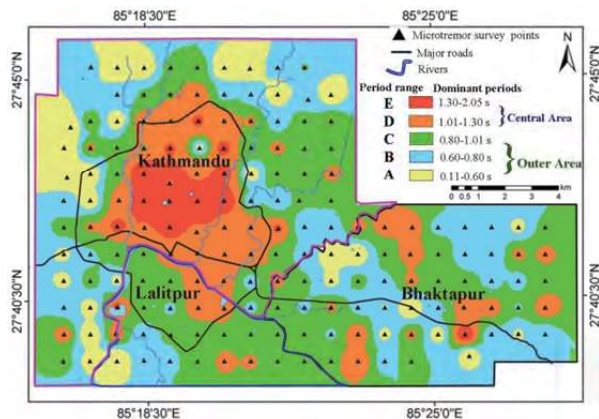
Fig. 5 Dominant natural period of ground of Kathmandu from microtremor analysis (after Poudyal et al. 2012)

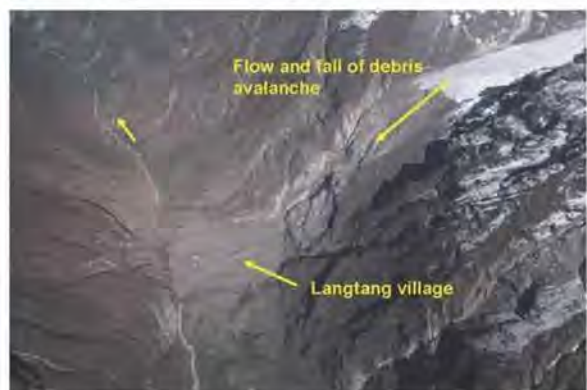
Debris flow and mud flow type of earthquake-induced landslide was not observed in the affected area due to dry season in the area, but rock fall triggered debris flow and avalanche was observed in the Langtang valley and killed more than 200 persons on the spot. The Langtang valley was vanished after this incident (Photo. 5).

Photo. 5 Debris flow and avalanche in Langtang village, source area also is shown in photo.

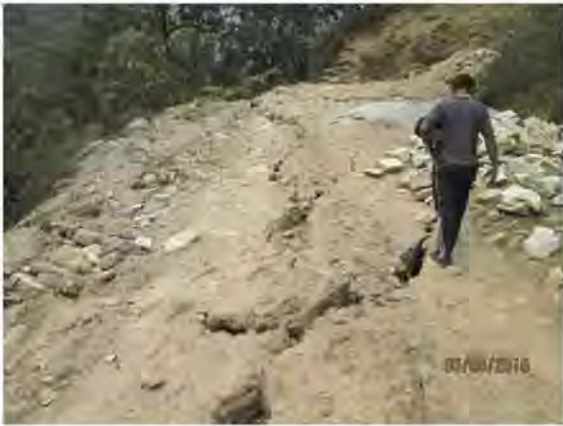
Photo. 7 Failure in Cut-and-fill part of rural road (Photo: Prem Khatri)

Cut-and-fill failures were very common in mountain roads in the affected area. Cut-and-fill land were also damaged in settlement area of Kathmandu (Photo 7).

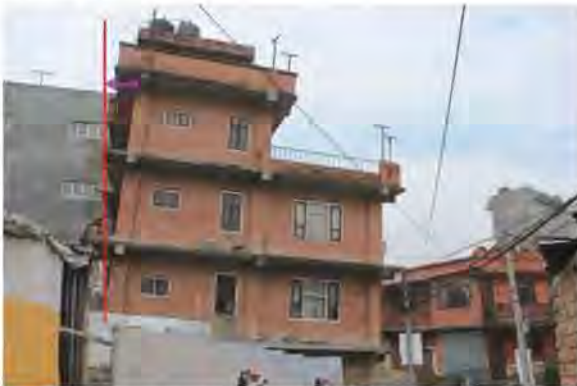
The Gorkha Earthquake was destructive not only due to structural weakness of the construction but there were many problem of differential settlement of the ground. Field visit during rapid damage assessment in Kathmandu valley suggested that nearly 40% of damages were due to land subsidence. Similarly, land subsidence due to liquefaction of lower sandy strata was also another problems observed in various location of the Kathmandu valley (Photo. 8).

Photo. 8 Land subsidence and tilting of house due to liquefaction of lower strata
